**NONDESTRUCTIVE ANALYSIS OF  
SALES GAS LINE PIPE EVIDENCE  
FROM THE WEST COTE BLANCHE  
BAY PIPELINE RUPTURE INCIDENT**

**Prepared For The  
NATIONAL TRANSPORTATION  
SAFETY BOARD  
Washington, DC**

**FEBRUARY 27, 2007**

**PN 131454**

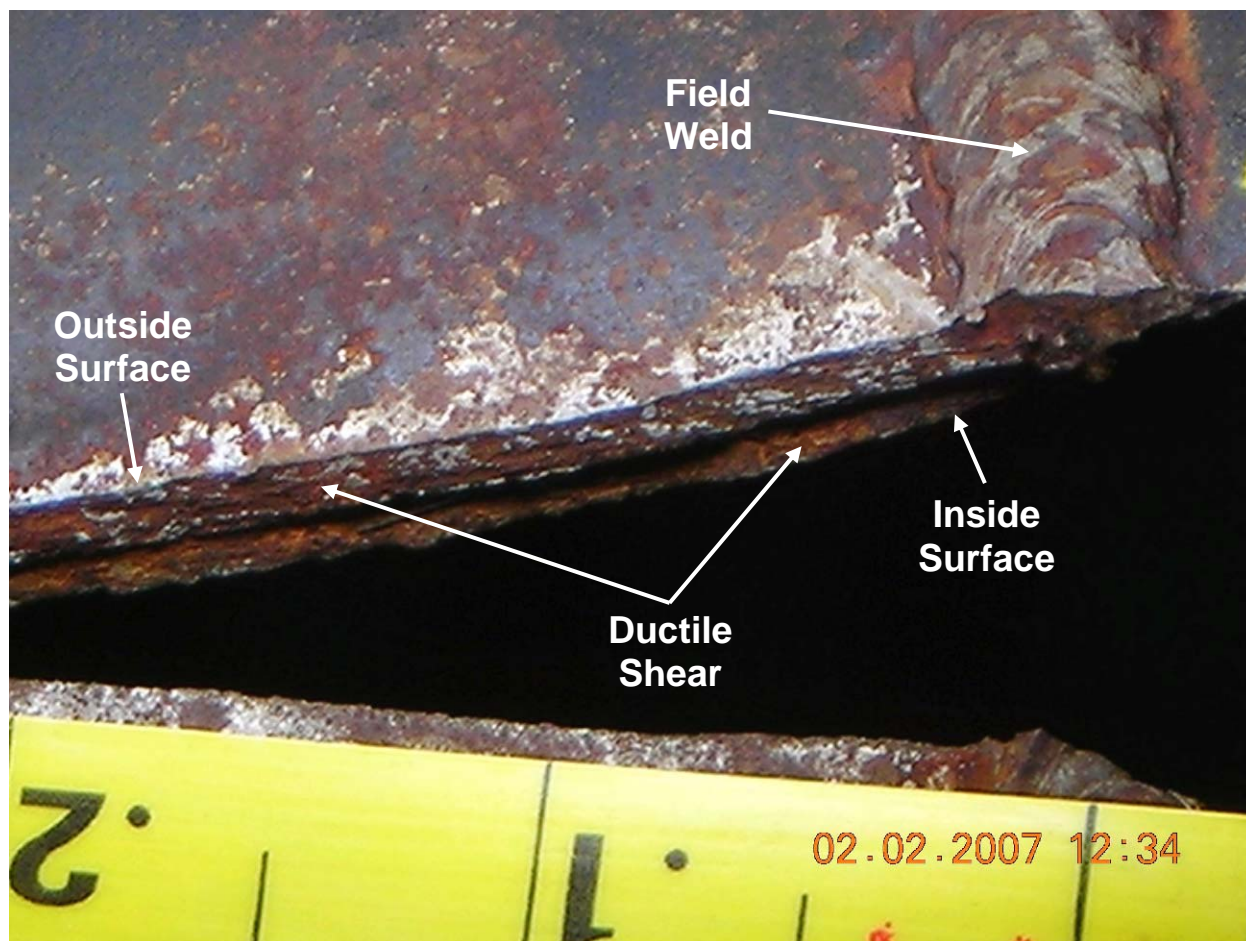
Figure 39 shows the east end of the longitudinal fracture in the east portion of the sales gas line. The fracture has ductile shear morphology after the fracture crossed the field girth weld.

**Figure 39:** Close-up view of the east end of the longitudinal fracture in the east portion of the sales gas line showing ductile shear after the fracture crossed the field girth weld.

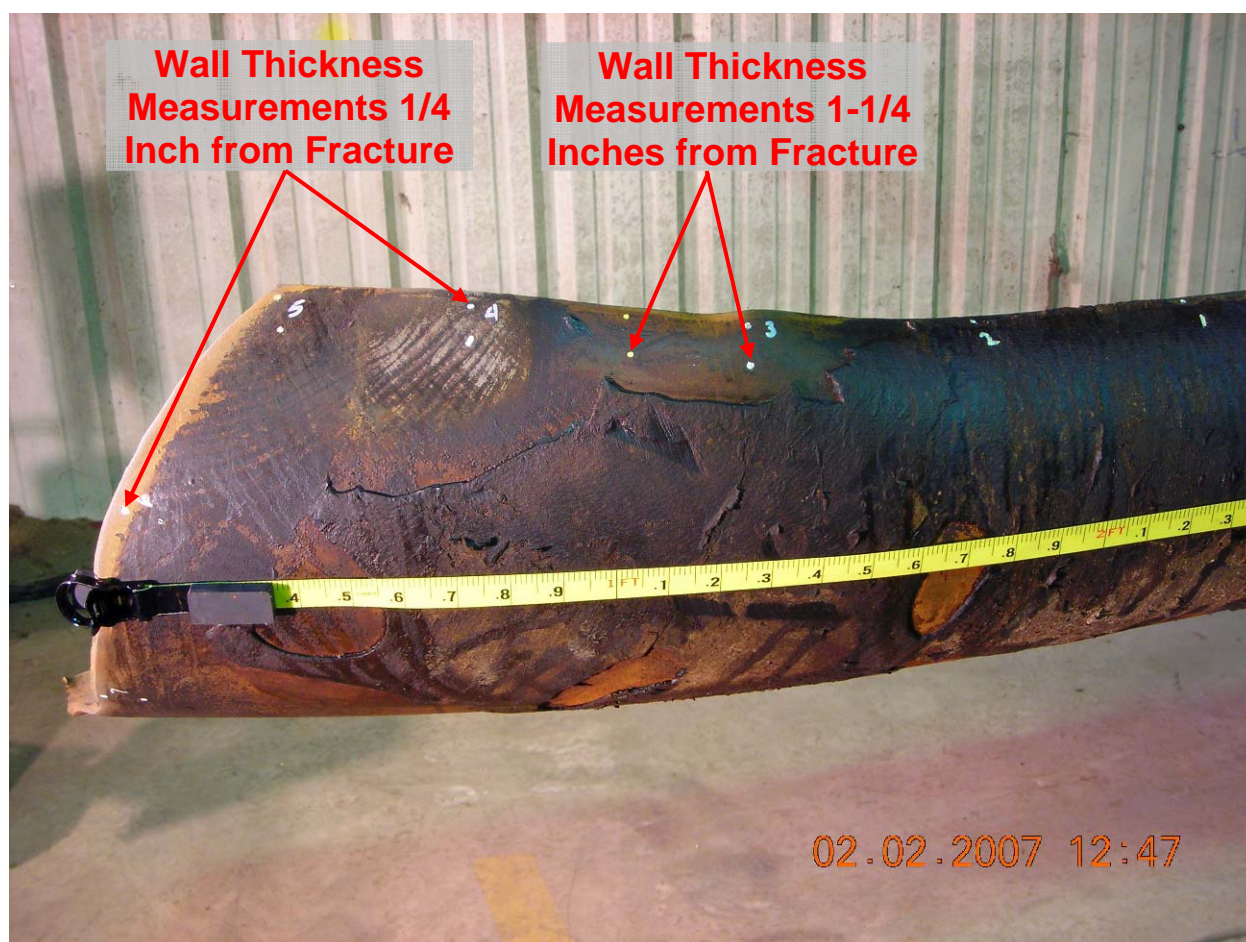
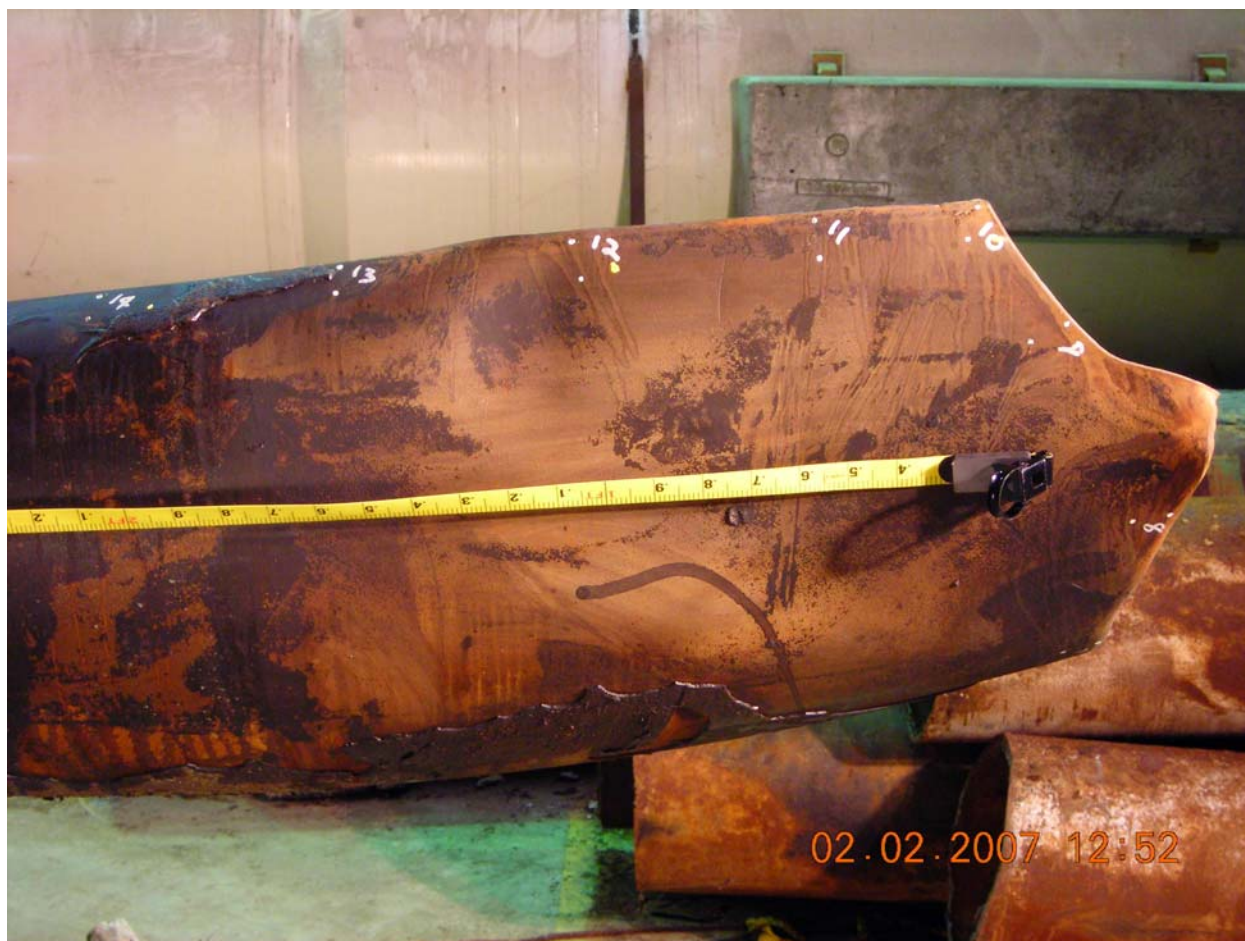
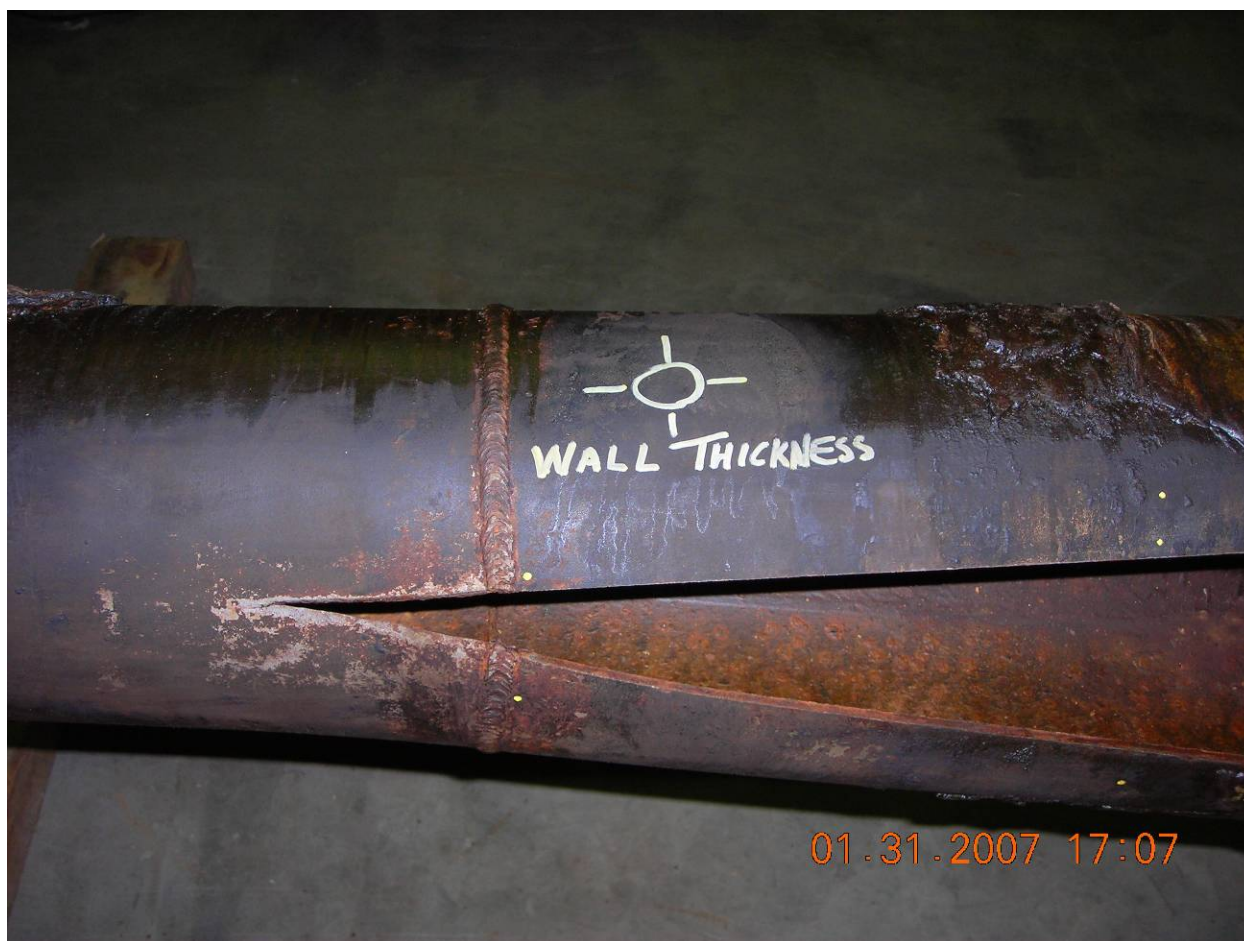
Wall thickness measurements were made along the longitudinal and transverse fractures at the west end of the east portion of the sales gas line and in a remote location near the east end of the longitudinal fracture. The measurements were made using a snap gage micrometer. Along the fractures, measurements were made approximately 1/4-inch from the fracture surface and 1-1/4 inches from the fracture surfaces (Figures 40 and 41). Figure 42 shows the location of the remote wall thickness measurement. The surfaces of the pipe were not cleaned to bare metal for the measurements. The wall thickness measurements are presented in Table 1 along with the nominal wall thickness for new pipe.

Location (see Figures 40-42)	Nearby Fracture	Wall Thickness (Inches)	
		1/4-Inch from Fracture	1-1/4 Inch from Fracture
1	Longitudinal	0.258	Coating Interference
2	Longitudinal	0.255	Coating Interference
3	Longitudinal	0.263	0.250
4	Longitudinal	0.254	0.249
5	Longitudinal/Transverse	0.239	0.249
6	Transverse	0.227	0.244
7	Transverse	0.223	0.245
8	Transverse	0.239	0.242
9	Transverse	0.239	0.239
10	Longitudinal/Transverse	0.201	0.210
11	Longitudinal	0.252	0.245
12 (close to origin)	Longitudinal	0.258	0.249
13	Longitudinal	0.256	0.250
14	Longitudinal	0.255	0.252
<hr/>			
		Other Location	
Remote	None	0.252	NA
Nominal-New Pipe	None	0.250	NA

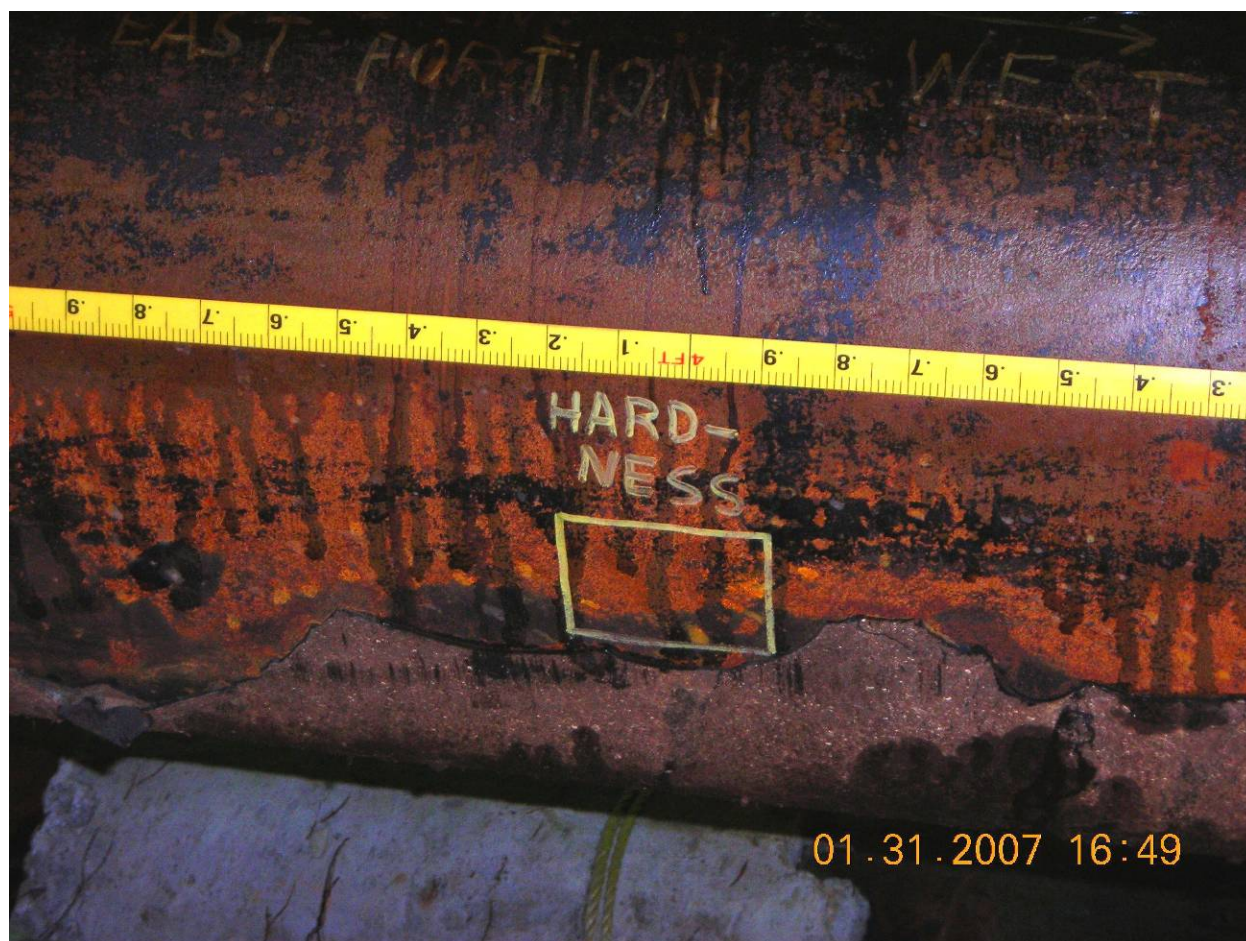
Ten hardness measurements were made in a remote location approximately four feet east of the transverse fracture in the east portion of the sales gas line (Figure 43). This location was not in the vicinity of a weld. The outside surface of the pipe was mechanically polished to a final finish of 600-grit abrasive paper prior to testing. The measurements were made using a Microdur II hardness tester. The hardness measurements ranged from Rockwell B 83.0 to 86.3 with an average of 84.9.

**Figure 43:** The remote location, approximately four feet east of the transverse fracture in the east portion of the sales gas line, where hardness measurements were made.

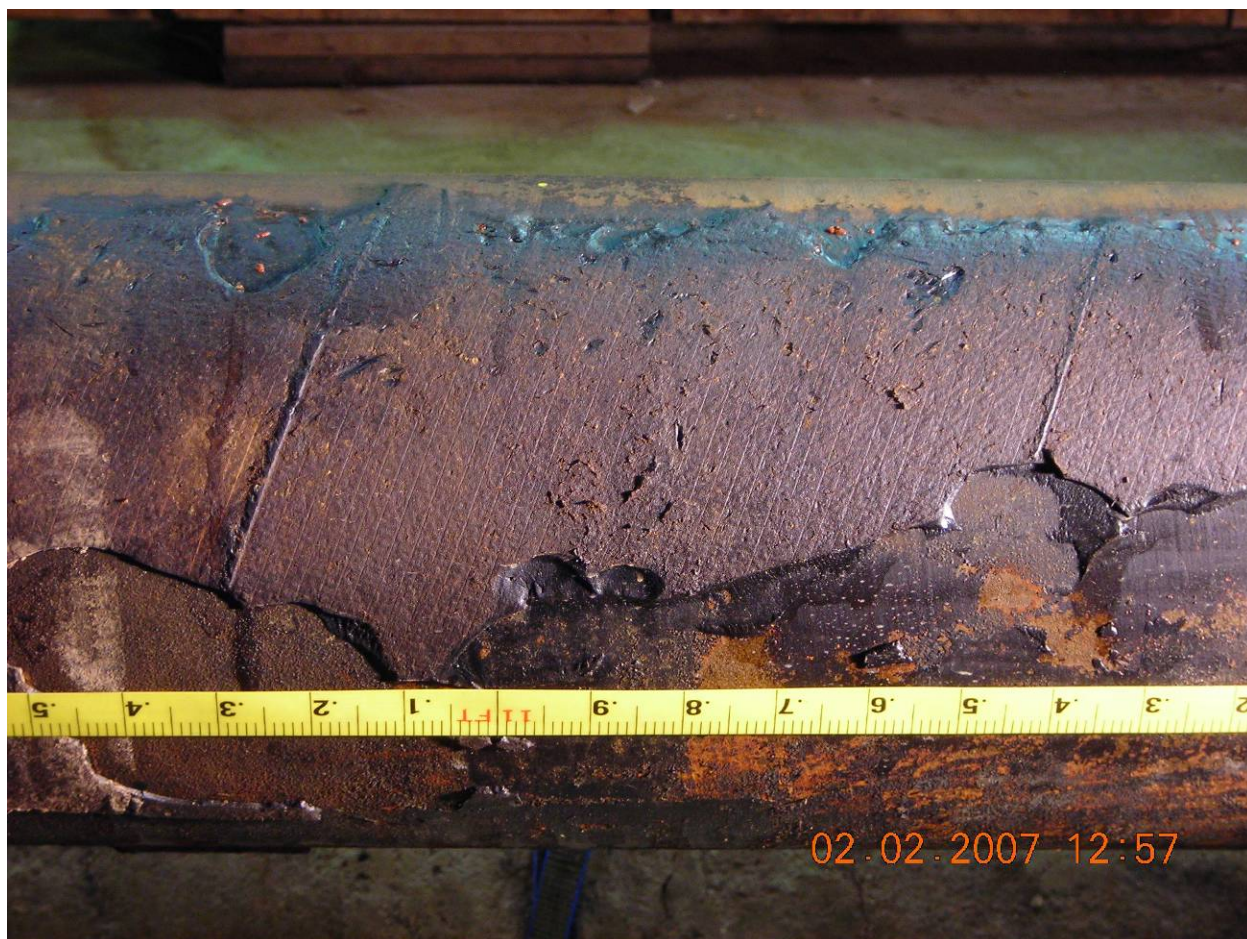
The exterior of the sales gas line pipes had been coated with a plant applied, spiral wrapped, asphalt-type coating shown in Figure 44, except for the ends that were welded in the field. The pipes were then coated with wire-reinforced concrete on top of the spiral wrapped asphalt (Figures 5, 6, 13, 16, 18, and 20). The thickness of the concrete ranged from 1.2 to 1.5 inches in

**Figure 44:** Spiral-wrapped asphalt-type coating on the outside surface of the east portion of the sales gas line.
